# PRELIMINARY WATER BALANCE ASSESSMENT

6586 Beatty Line North, Township of Centre Wellington,  
County of Wellington, ON

Project #: 24-0837

Date: January 7, 2025

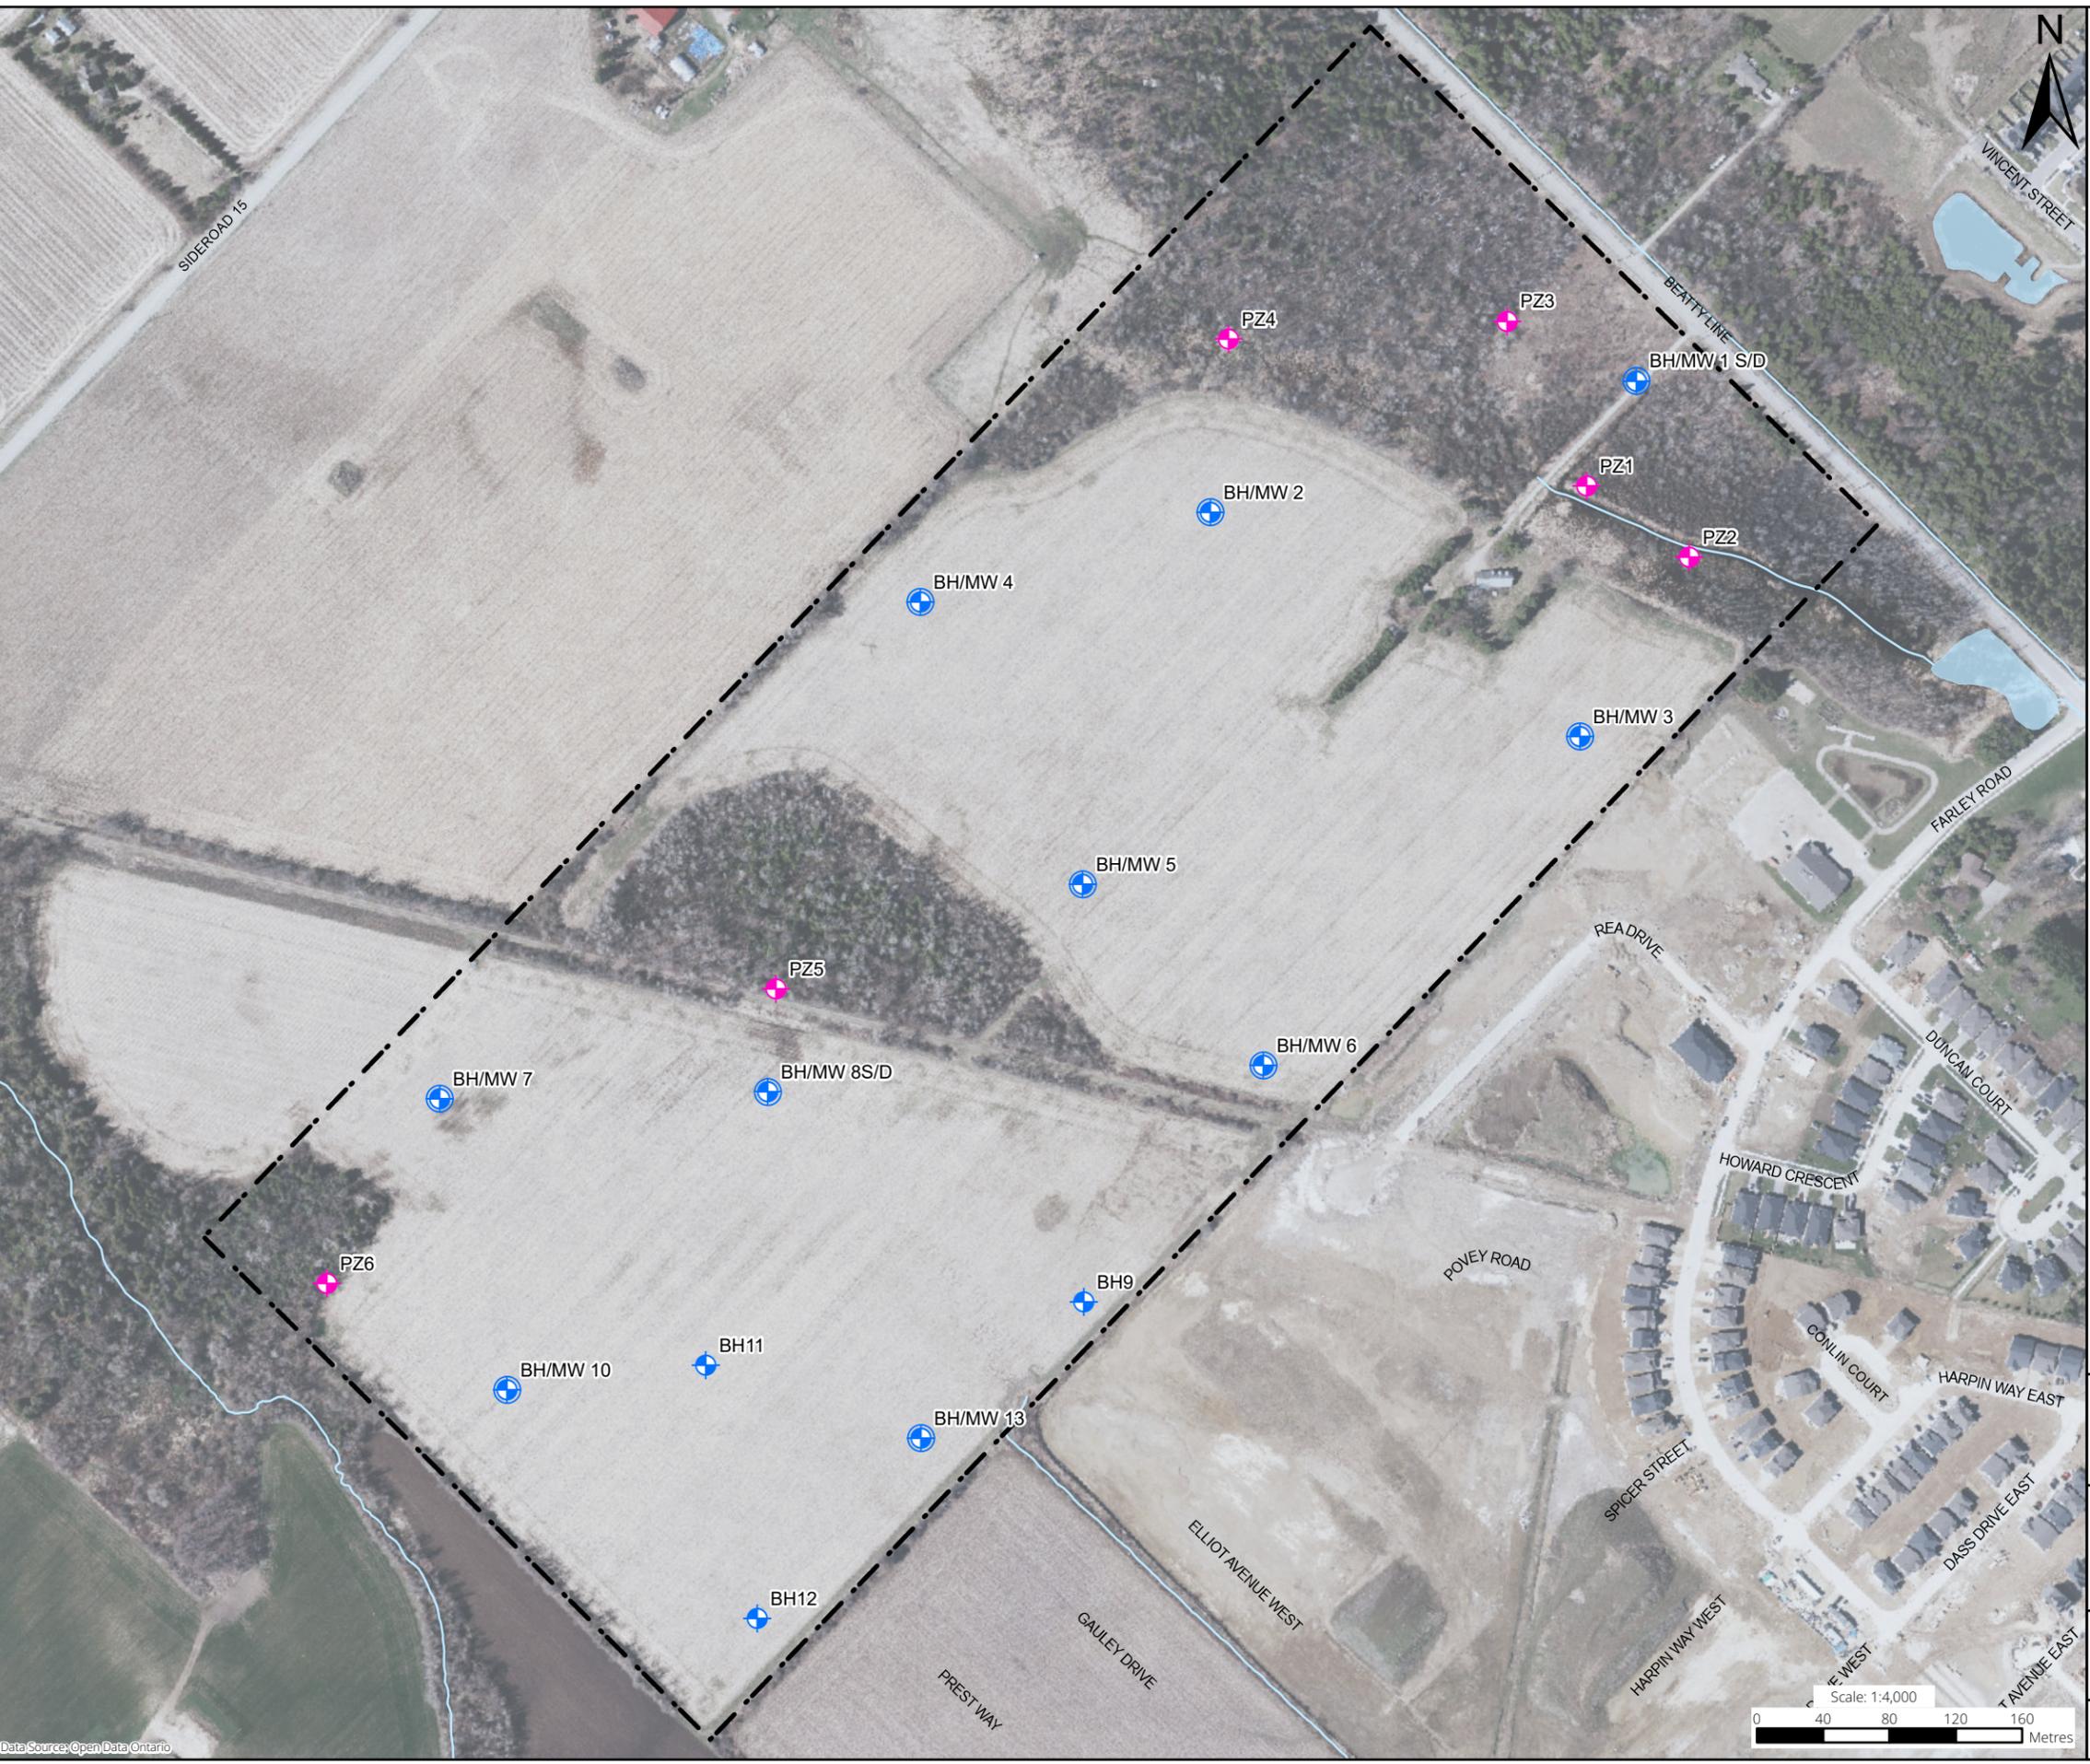
TITLE SITE INSTRUMENTATION BY OTHERS				
PROJECT PRELIMINARY WATER BALANCE ASSESSMENT 6586 BEATTY LINE TOWNSHIP OF CENTRE WELLINGTON, ONTARIO				
CLIENT SORBARA/TRIBUTE BRUBACHER HOLDINGS INC.				
PROJECT NO. 24-0837	DATE DECEMBER 2024	PREPARED BY TP	APPROVED BY RB	FIGURE 2

- SITE BOUNDARY
- WATERCOURSE
- WATERBODY
- MONITORING WELL (STANTEC 2024)
- BOREHOLE LOCATION (STANTEC, 2024)
- PIEZOMETER (STANTEC 2024)

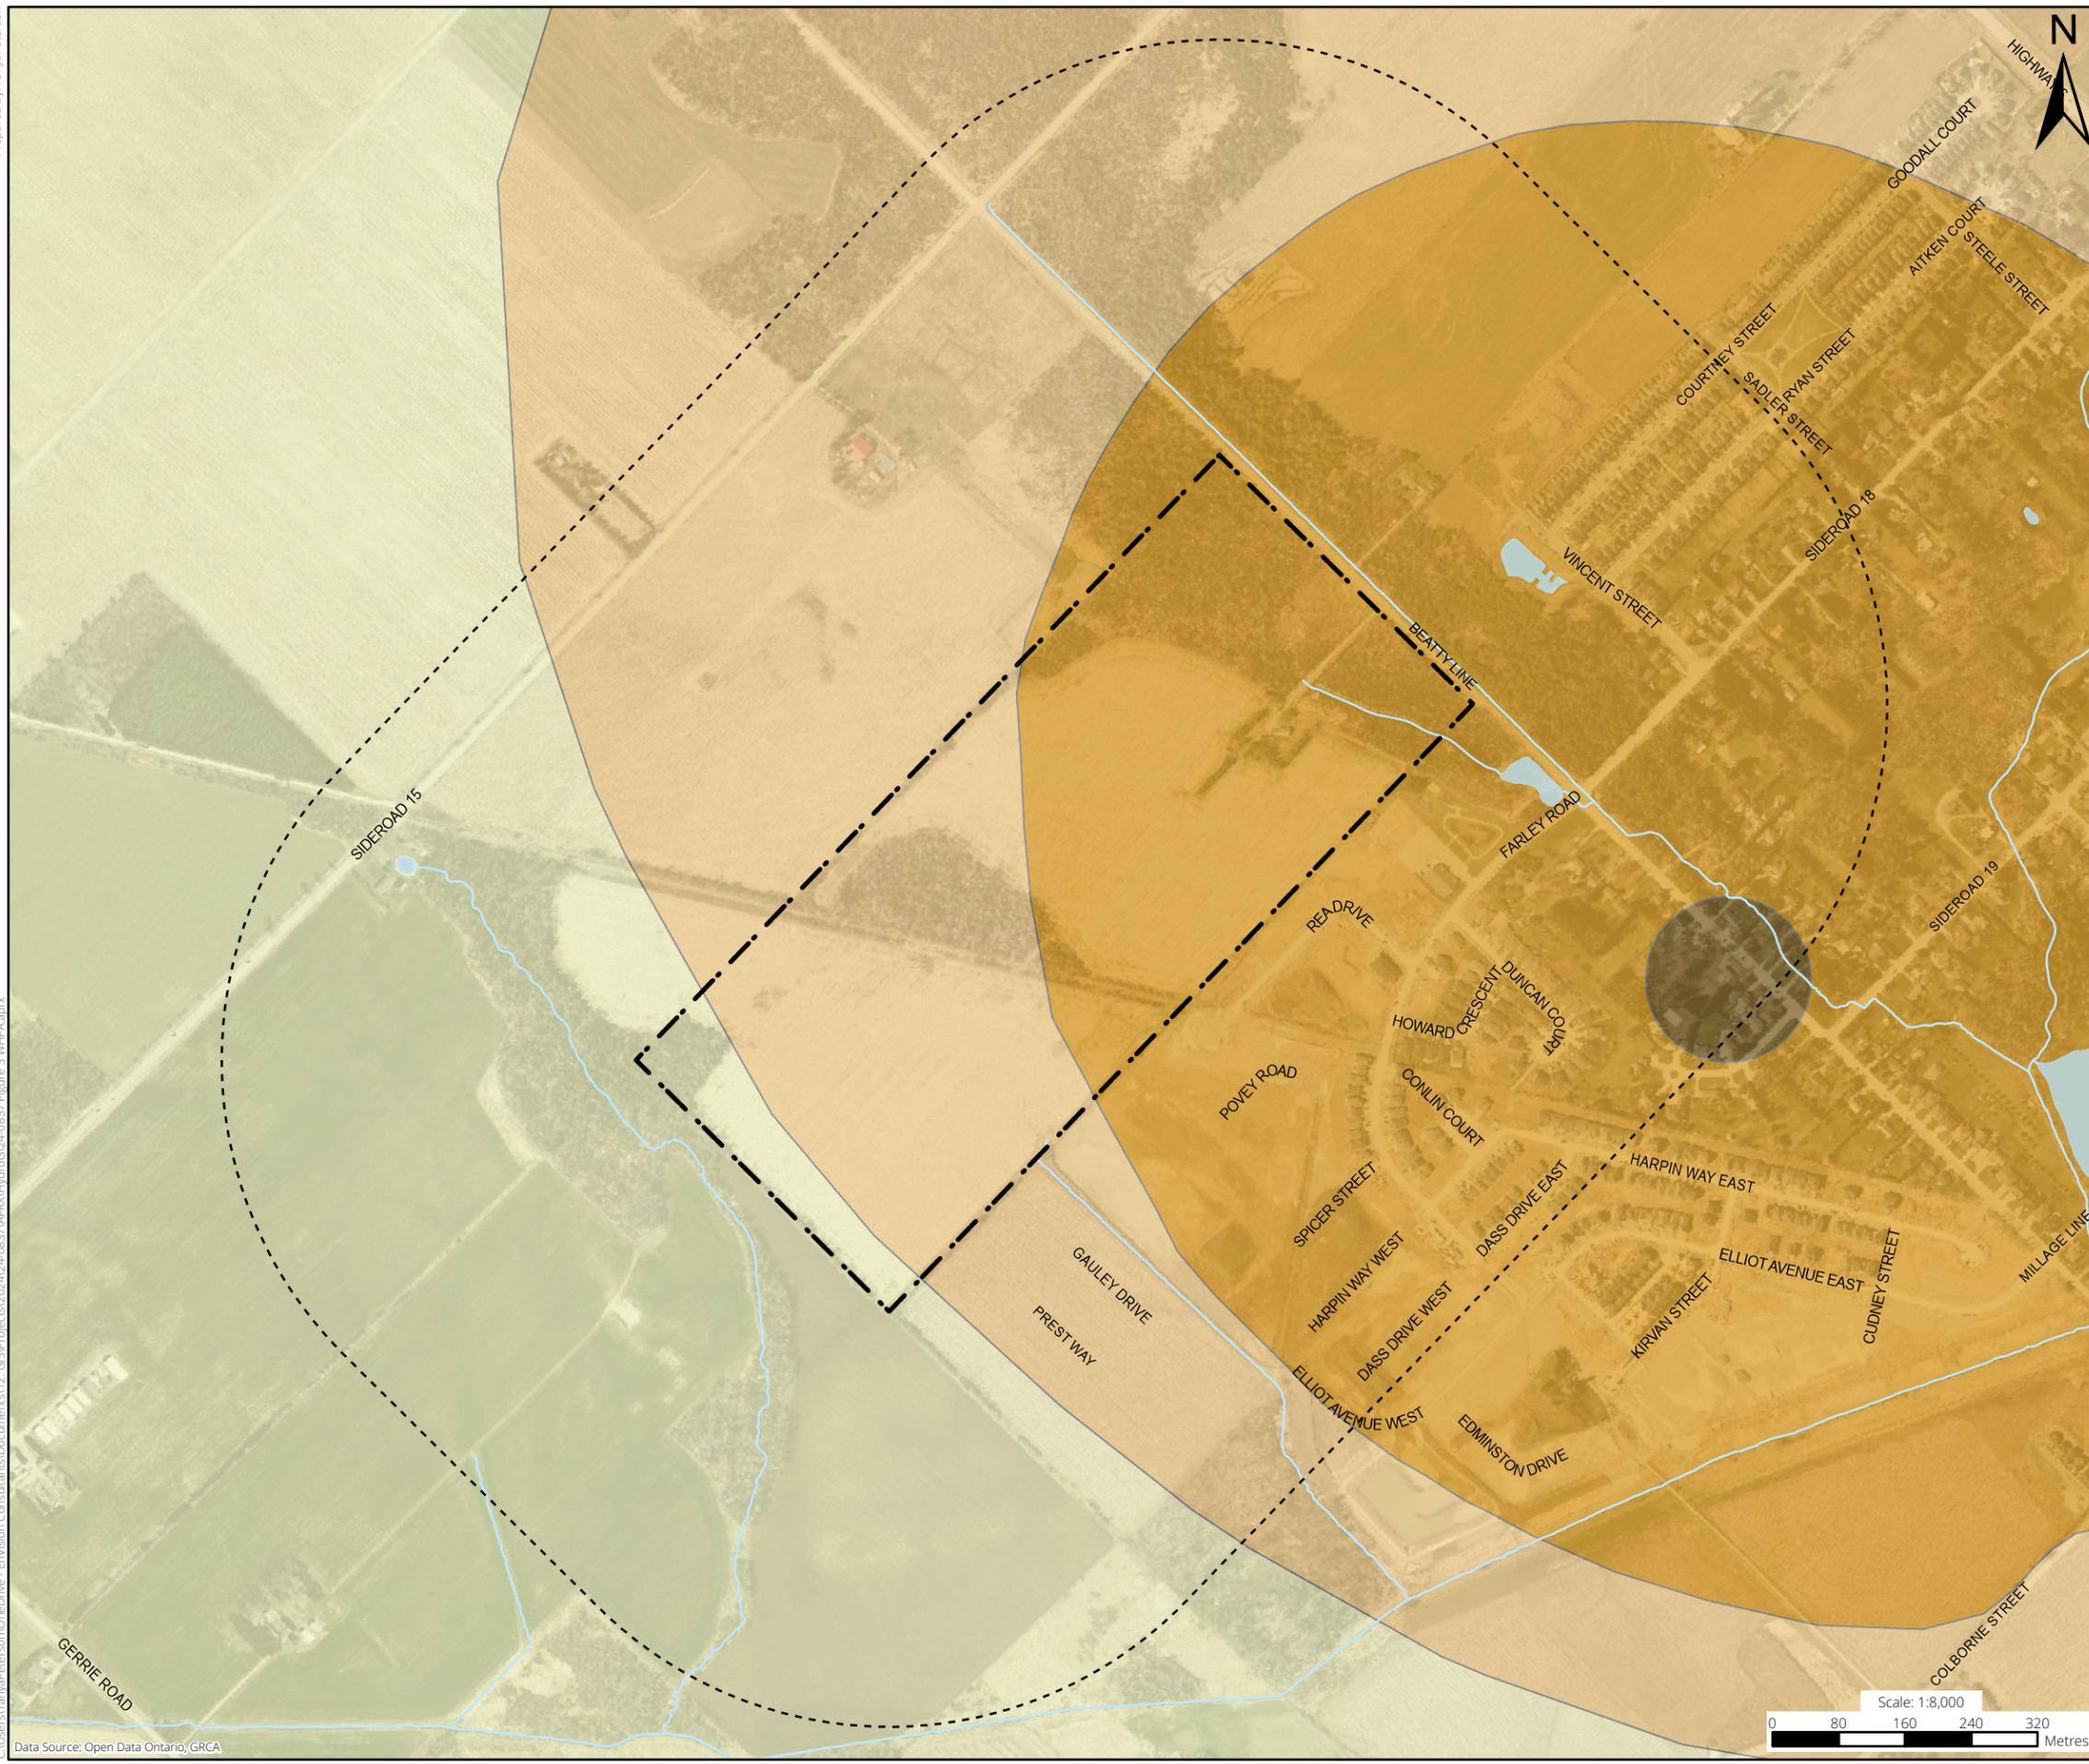
TITLE				
WELLHEAD PROTECTION AREAS				
PROJECT				
PRELIMINARY WATER BALANCE ASSESSMENT 6586 BEATTY LINE TOWNSHIP OF CENTRE WELLINGTON, ONTARIO				
CLIENT				
SORBARA/TRIBUTE BRUBACHER HOLDINGS INC.				
PROJECT NO.	DATE	PREPARED BY	APPROVED BY	FIGURE
24-0837	DECEMBER 2024	TP	RB	3

- SITE BOUNDARY
- 500 m BUFFER
- WATERBODY
- WATERCOURSE
- WHPA A
- WHPA B
- WHPA C
- WHPA D

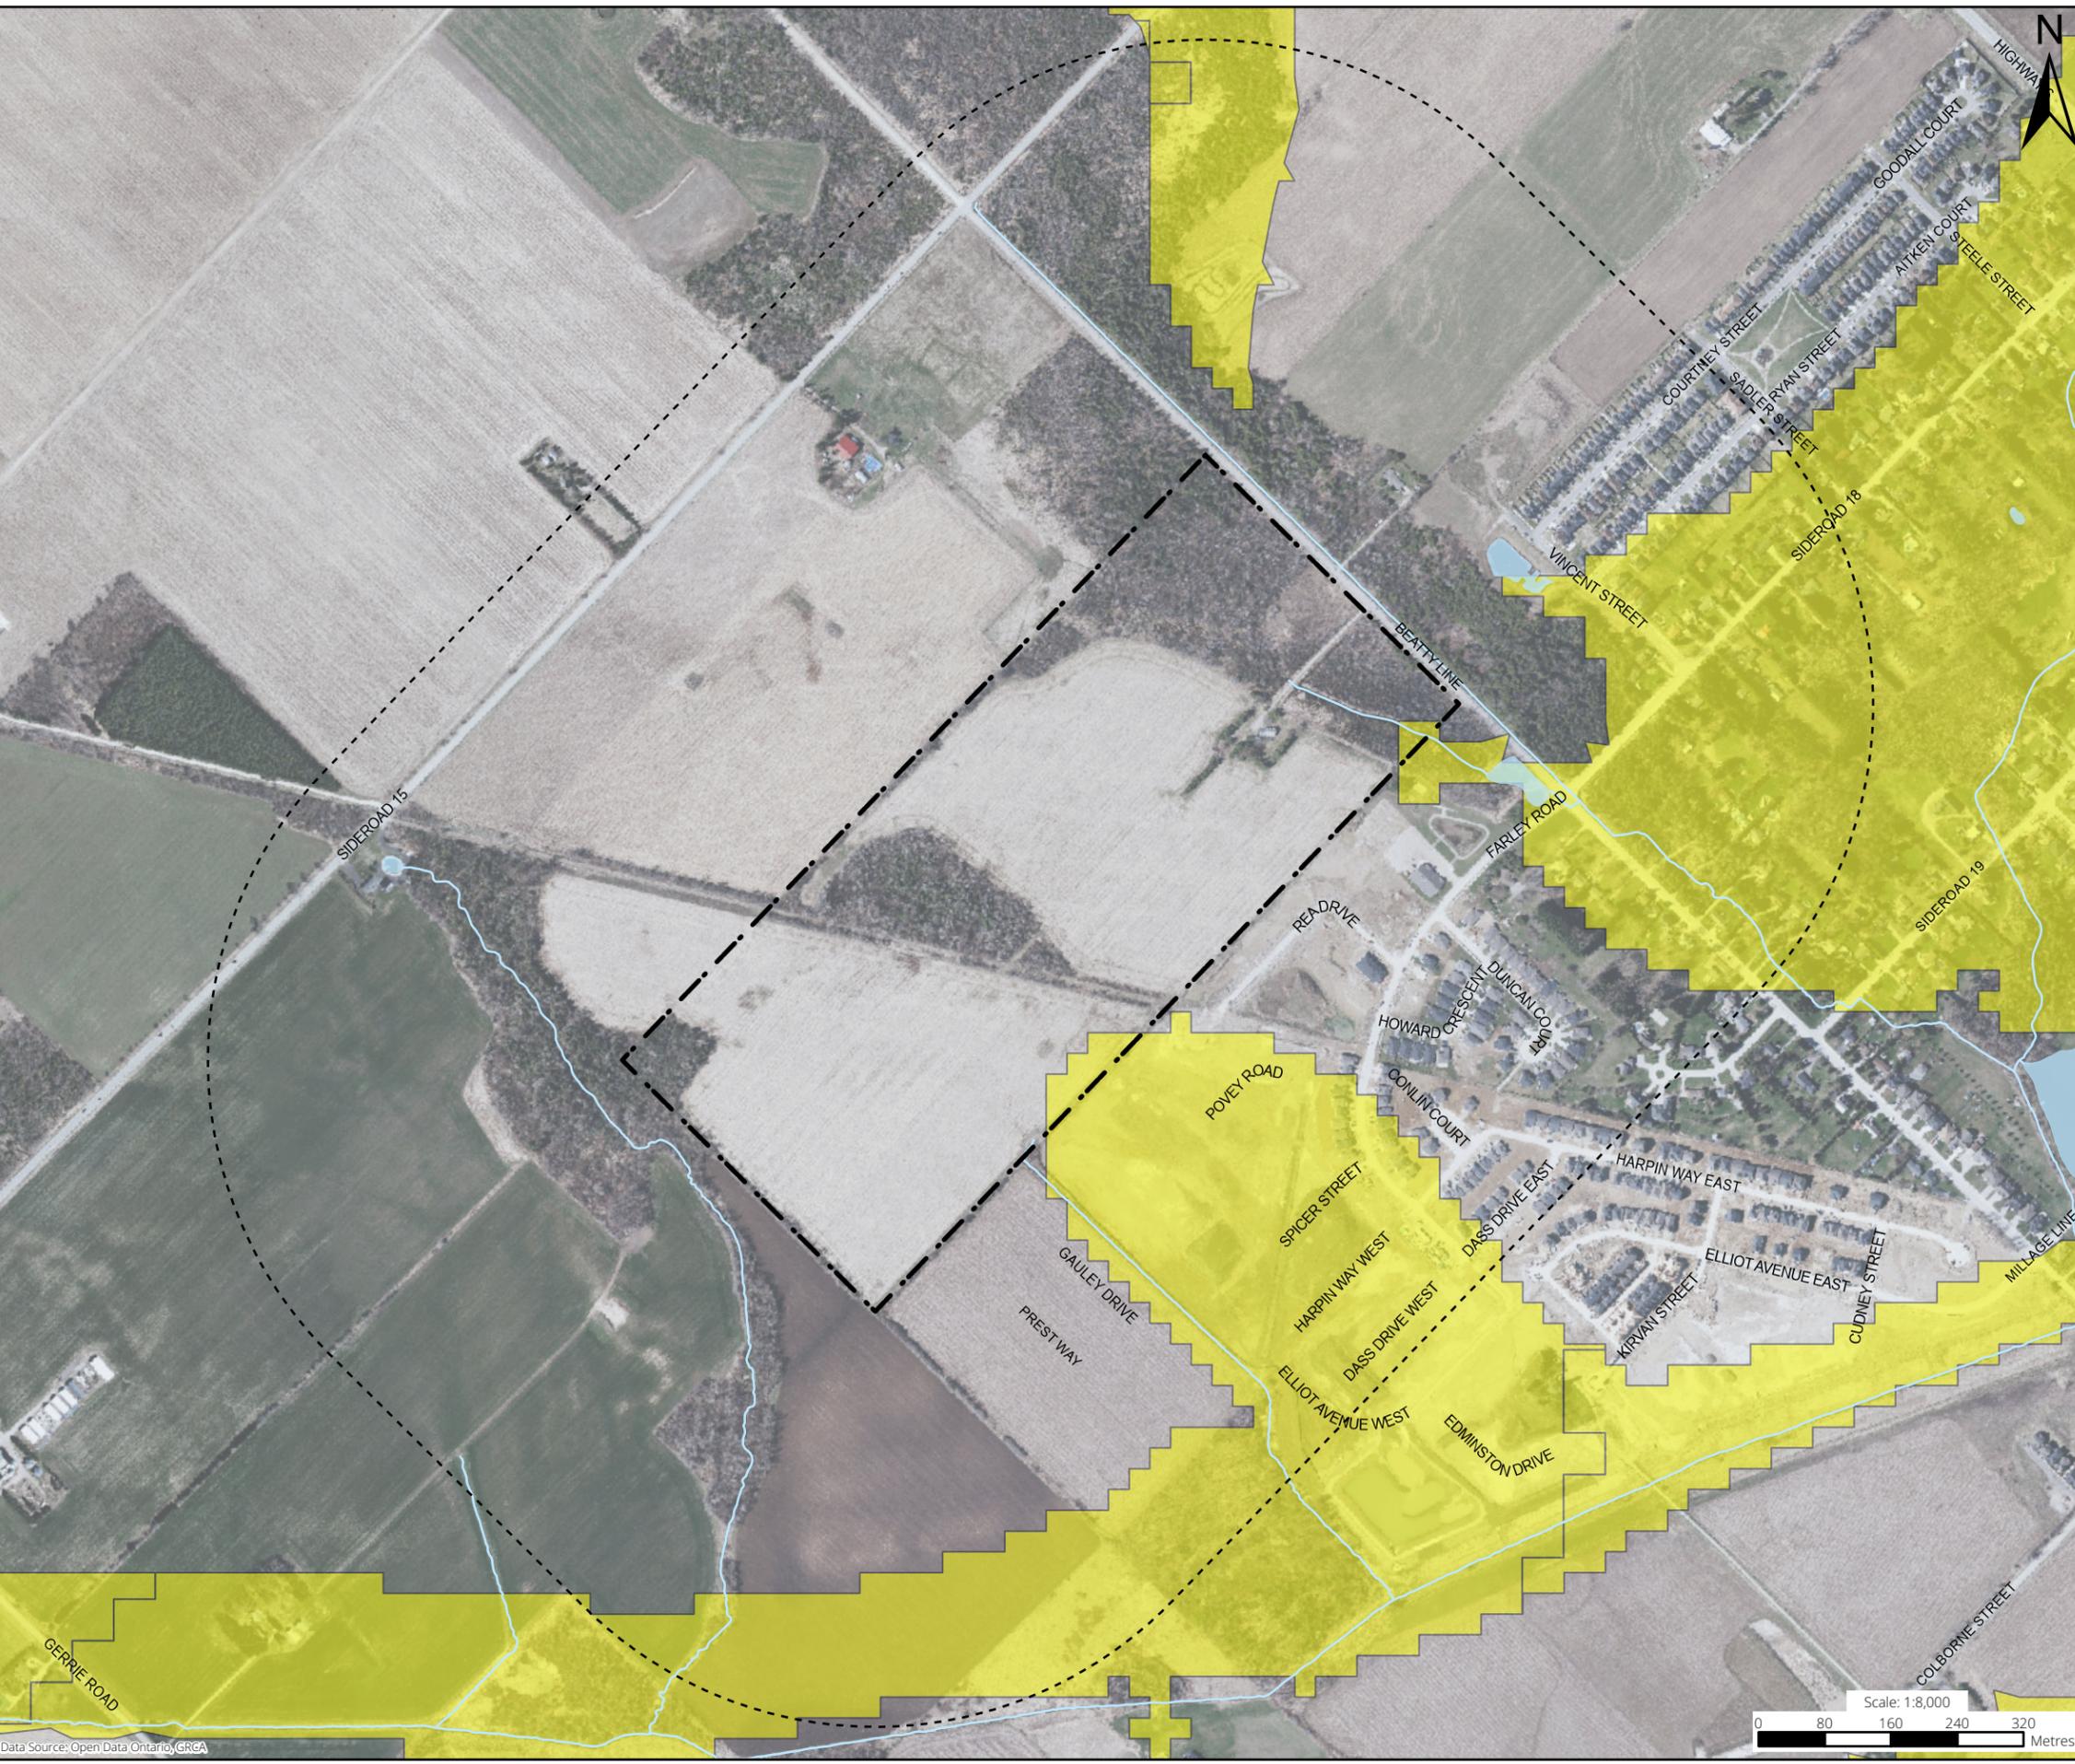
TITLE				
SIGNIFICANT GROUNDWATER RECHARGE AREA				
PROJECT				
PRELIMINARY WATER BALANCE ASSESSMENT 6586 BEATTY LINE TOWNSHIP OF CENTRE WELLINGTON, ONTARIO				
CLIENT				
SORBARA/TRIBUTE BRUBACHER HOLDINGS INC.				
PROJECT NO.	DATE	PREPARED BY	APPROVED BY	FIGURE
24-0837	DECEMBER 2024	TP	RB	4

- SITE BOUNDARY
- 500 m BUFFER
- WATERBODY
- WATERCOURSE
- SIGNIFICANT GROUNDWATER RECHARGE AREA (SGRA)

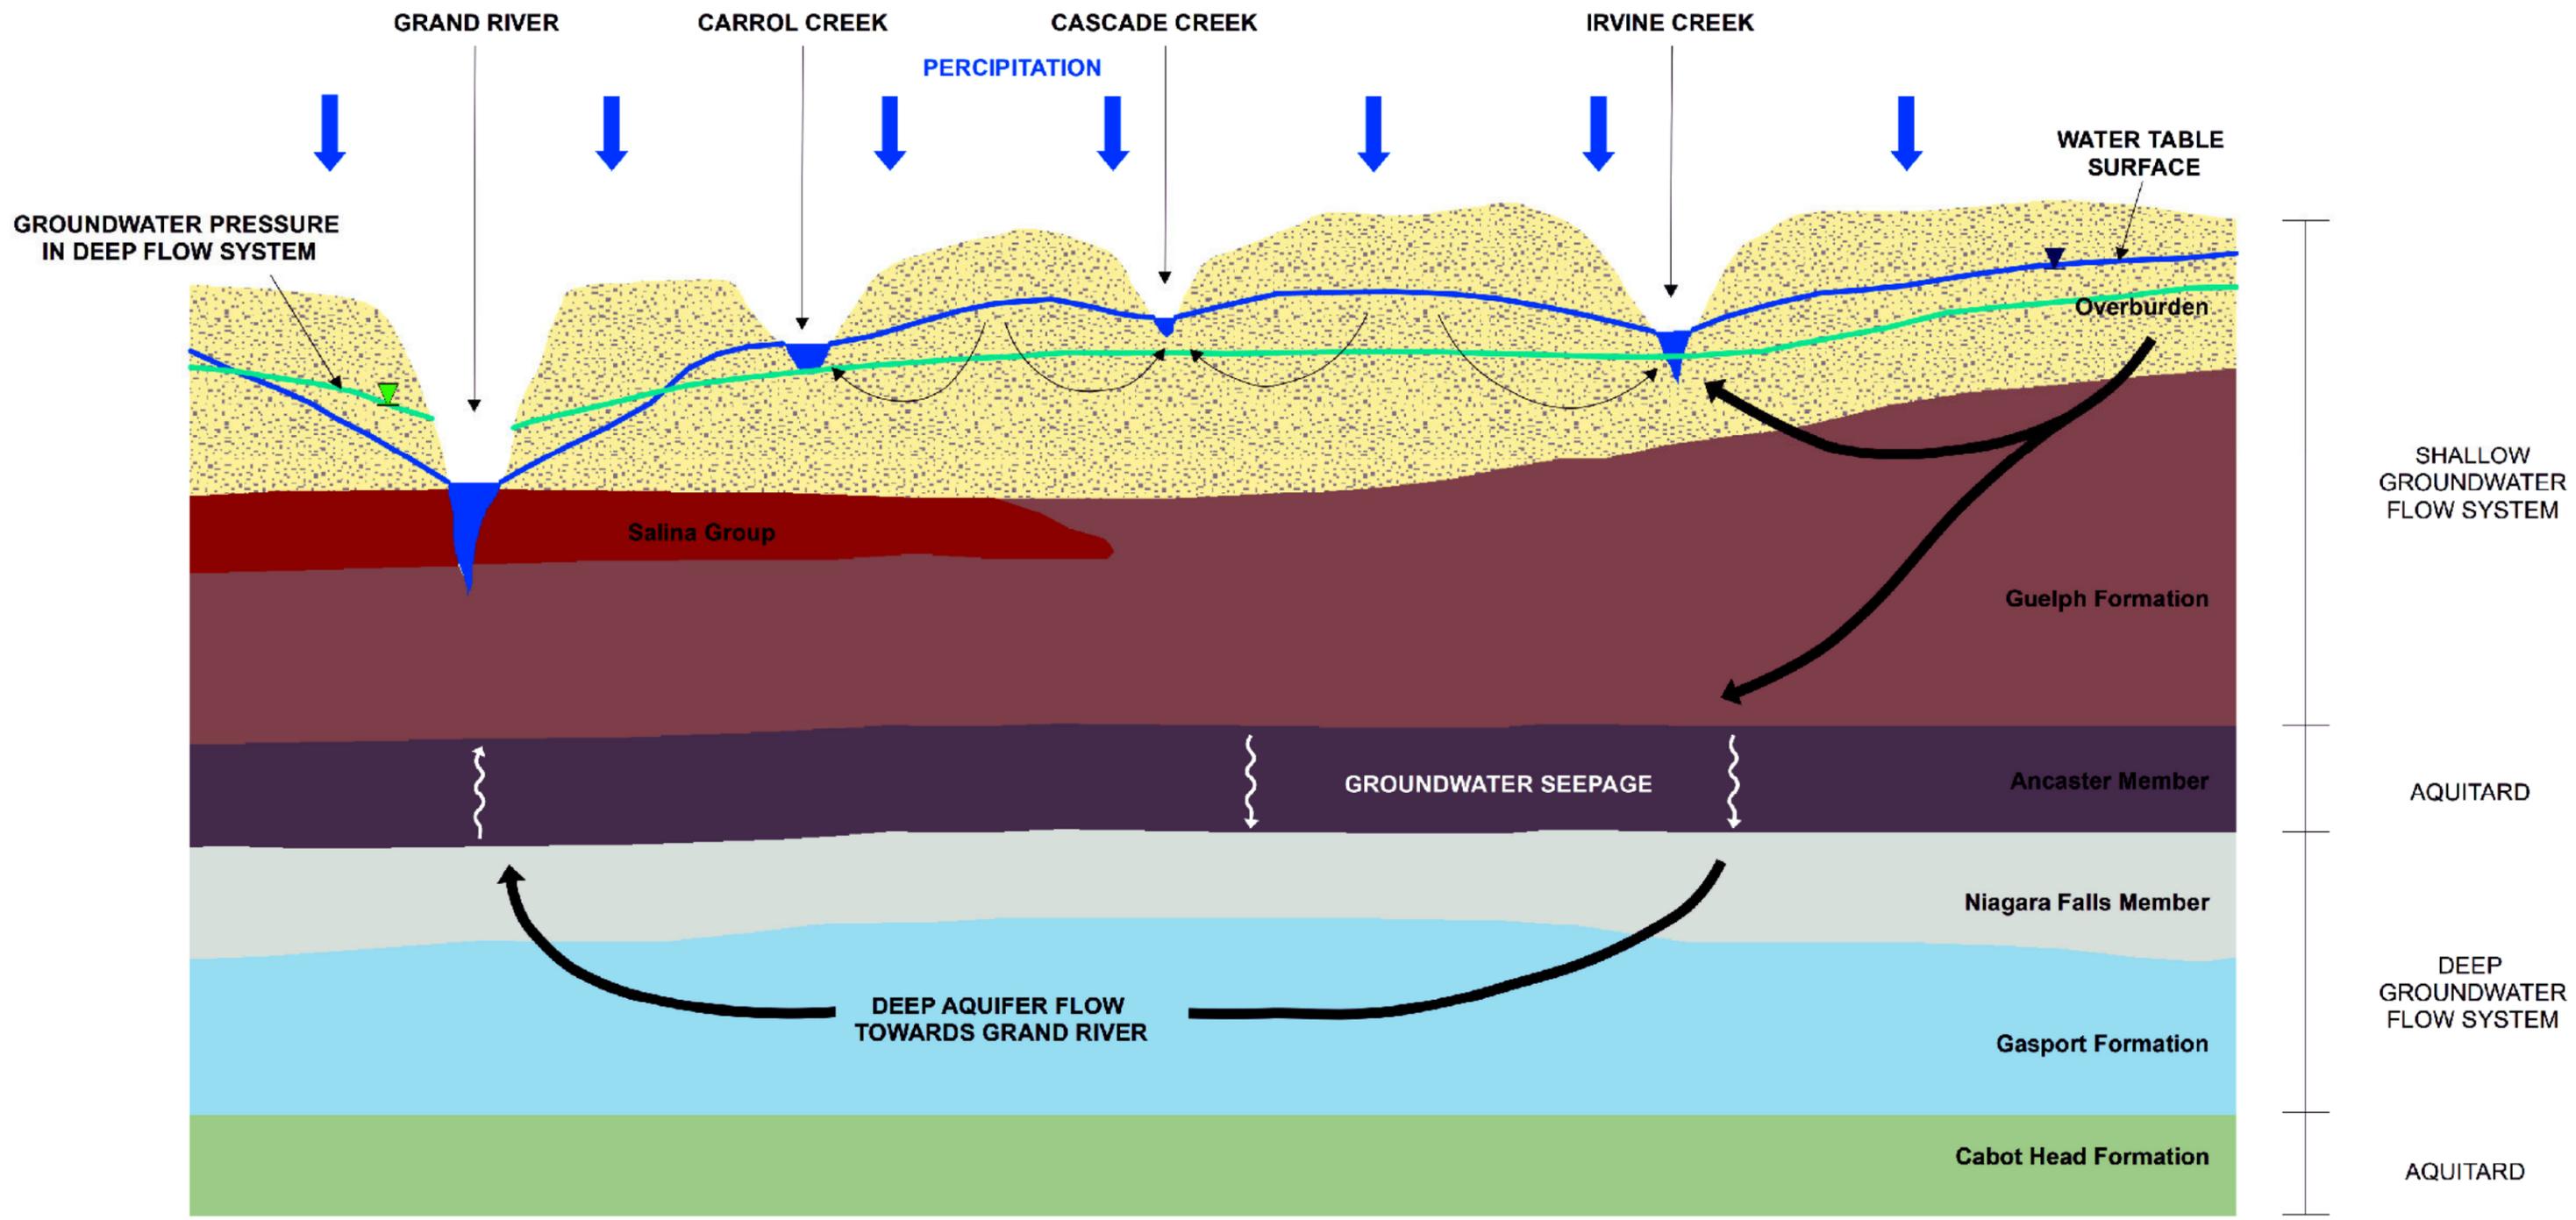
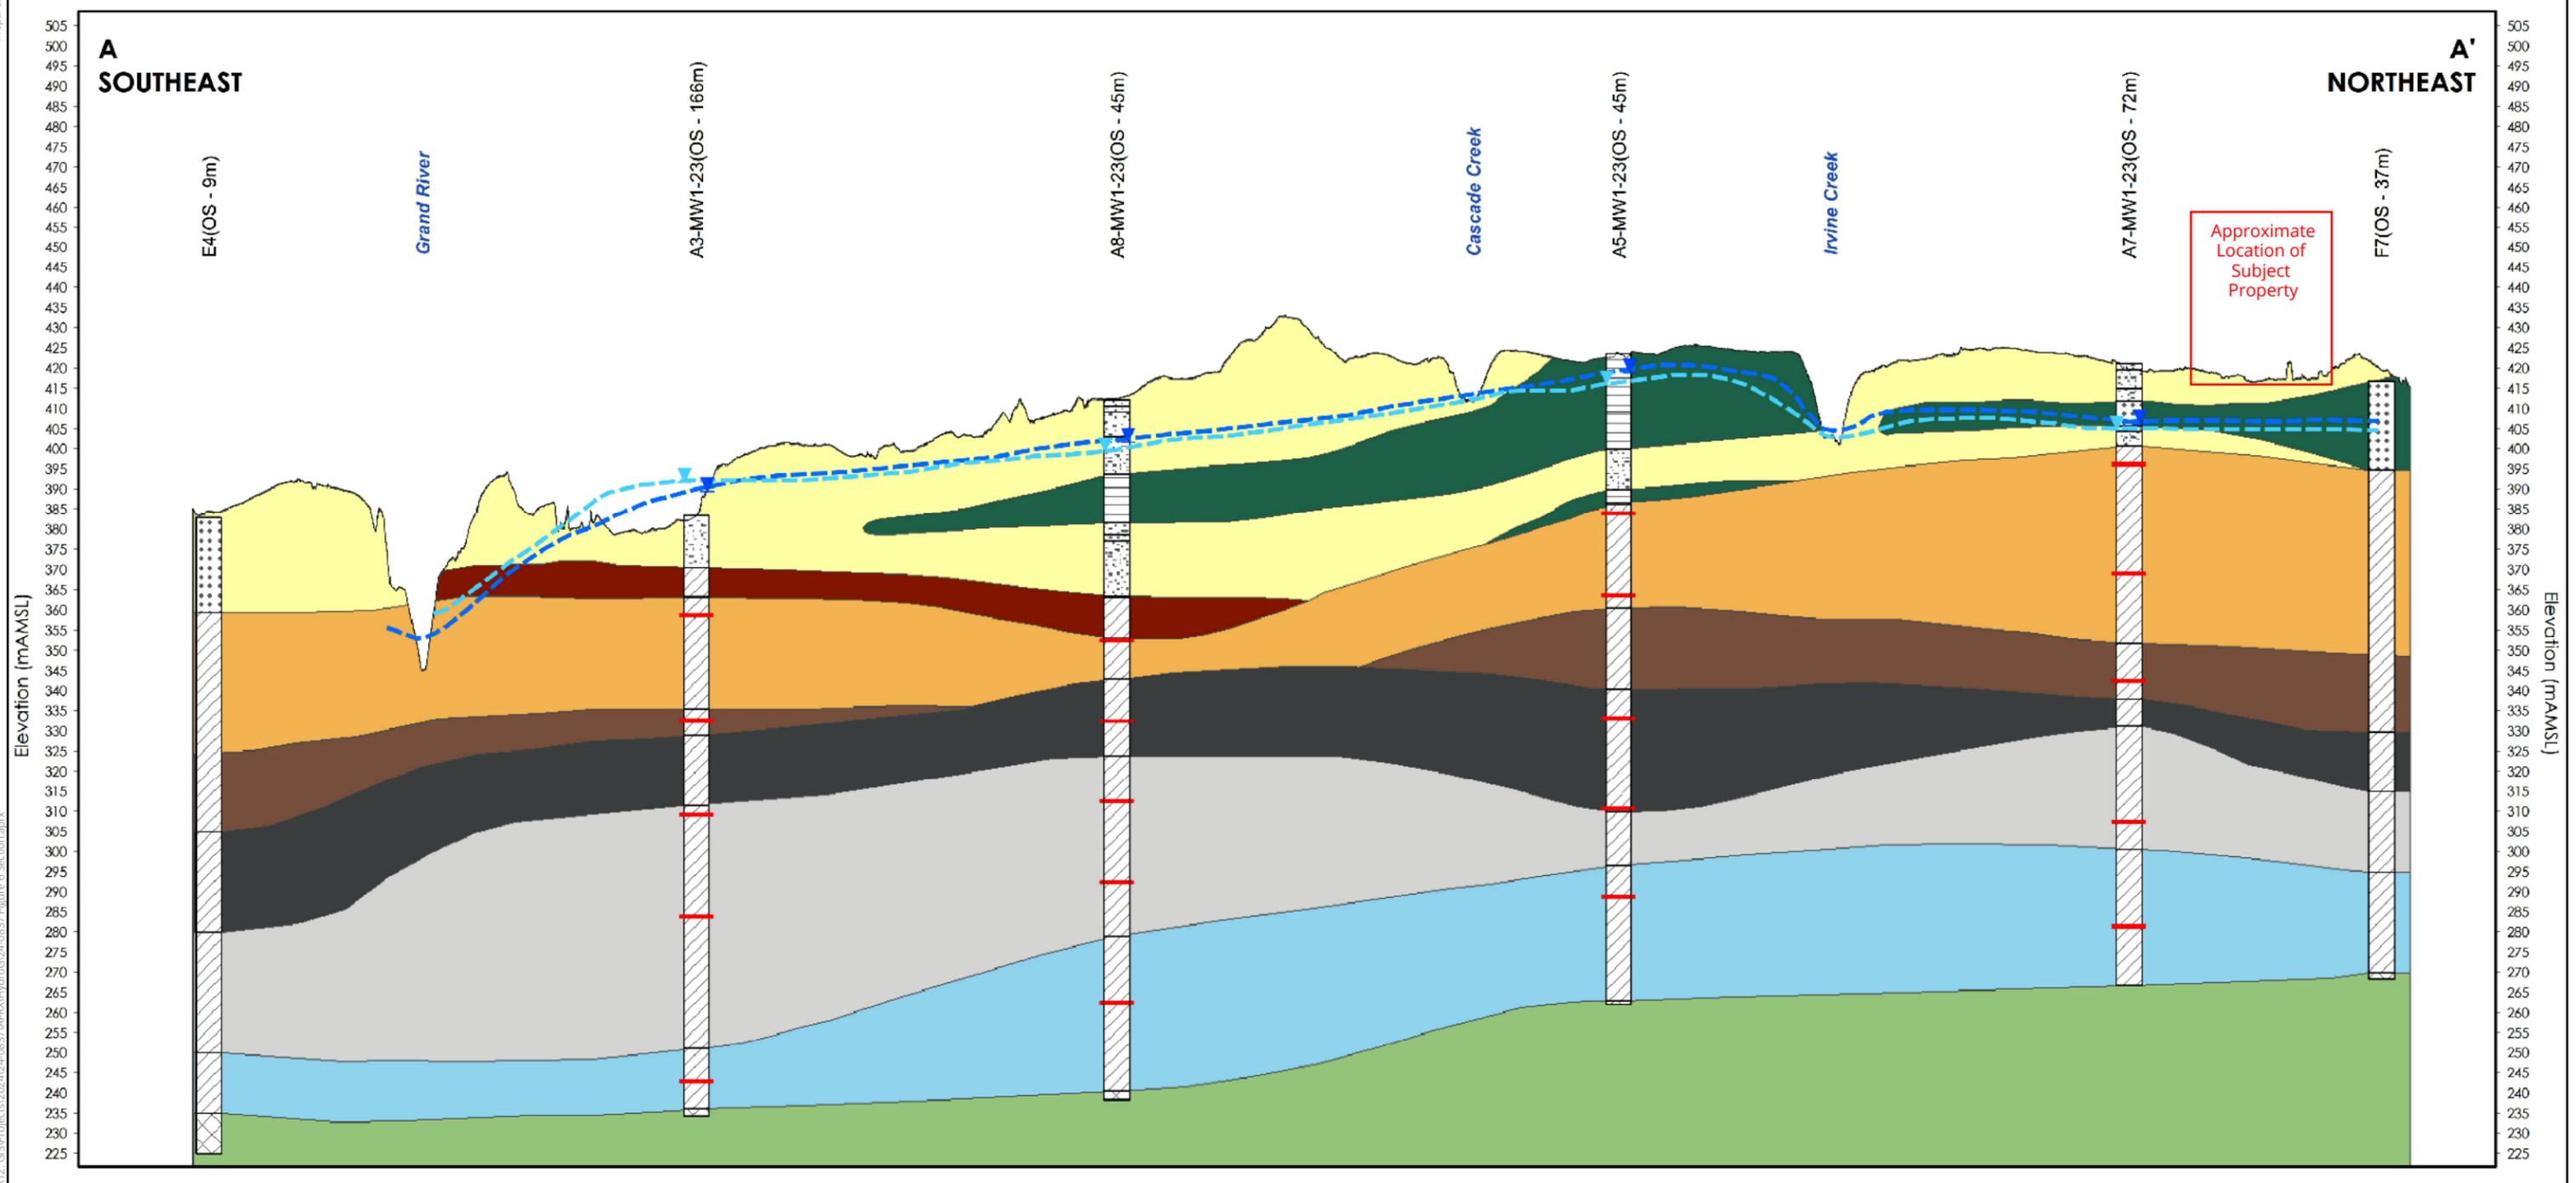
<b>PROJECT NO.</b> 24-0837	<b>DATE</b> DECEMBER 2024	<b>PREPARED BY</b> TP	<b>APPROVED BY</b> RB	<b>FIGURE</b> 6
-------------------------------	------------------------------	--------------------------	--------------------------	--------------------

- Existing Groundwater Pressure/Elevation in Deep Aquifer
- Water Table Surface in Shallow Aquifer

Legend		Stratigraphic Nomenclature		Borehole Material	
	Interpreted Deep Bedrock Groundwater Elevation		Elmira Moraine Sand		Sand and Gravel
	Interpreted Shallow Bedrock Groundwater Elevation		Maryhill Till		Silt Till
	Shallow Bedrock Groundwater Level		Salina		Clayey Silt Till
	Deep Bedrock Groundwater Level		Guelph (Hanlon)		Dolostone
	Vibrating Wire Piezometer		Guelph (Wellington)		Shale
			Goat Island (Ancaster)		
			Goat Island (Niagara Falls)		
			Gasport		
			Cabot Head

Geological and hydrogeological conditions throughout the Study Area and surrounding region have been documented in previous studies, including in work completed by Stantec for the New Well Exploration Feasibility Assessment Report, published in February of 2024 (Stantec, 2024). A copy of Stantec's conceptual hydrogeological model that includes portions of the Study Area, has been attached as **Figure 5**, and an interpretation of the stratigraphy beneath the Site and Study Area as **Figure 6**.

towards local creeks (Irvine Creek) as discharge. Beneath the Guelph Formation, the Ancaster Member acts as a regional aquitard, with some leakage serving to recharge the deep groundwater flow system (Niagara Falls/Gasport/Cabot Head Formations).

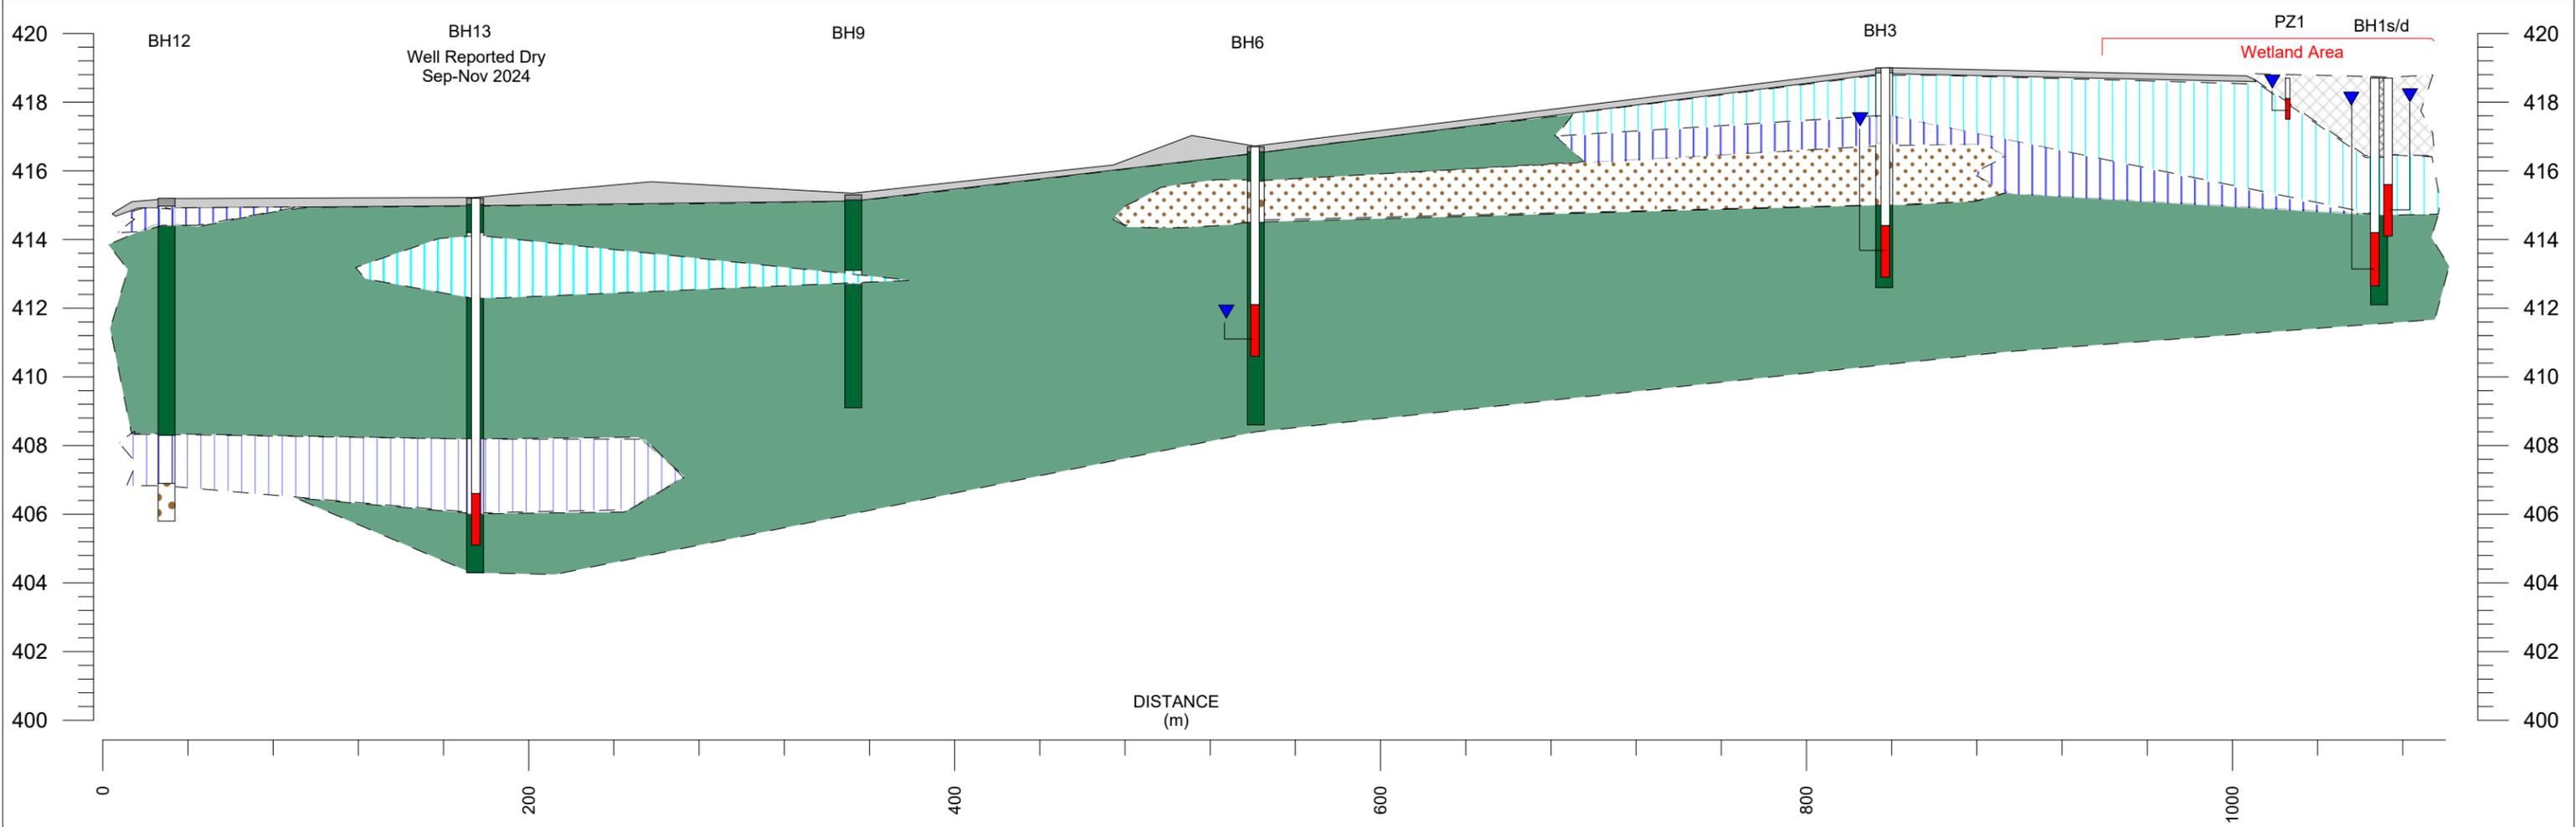
<p>CLIENT</p> <p>SORBARA/TRIBUTE BRUBACHER HOLDINGS INC.</p>	<p>TITLE</p> <p>SITE SPECIFIC CROSS SECTION (A-A')</p>

- Topsoil
- Earth fill
- Silt
- Silty clay
- Sand
- Sandy silt till
- Casing
- Screen
- Water Level (Sep. 2024, taken by Soil Engineers)

EnVision has prepared two cross sections from west to east, across the Site, which present a stratigraphic interpretation of the hydrogeological/geological conditions based off of the Soil Engineer borehole records. Cross Section A-A', which presents a profile along the southern half of the Site is included as **Figure 8**. Cross Section B-B', which presents a profile along the northern half of the Site is included as **Figure 9**.

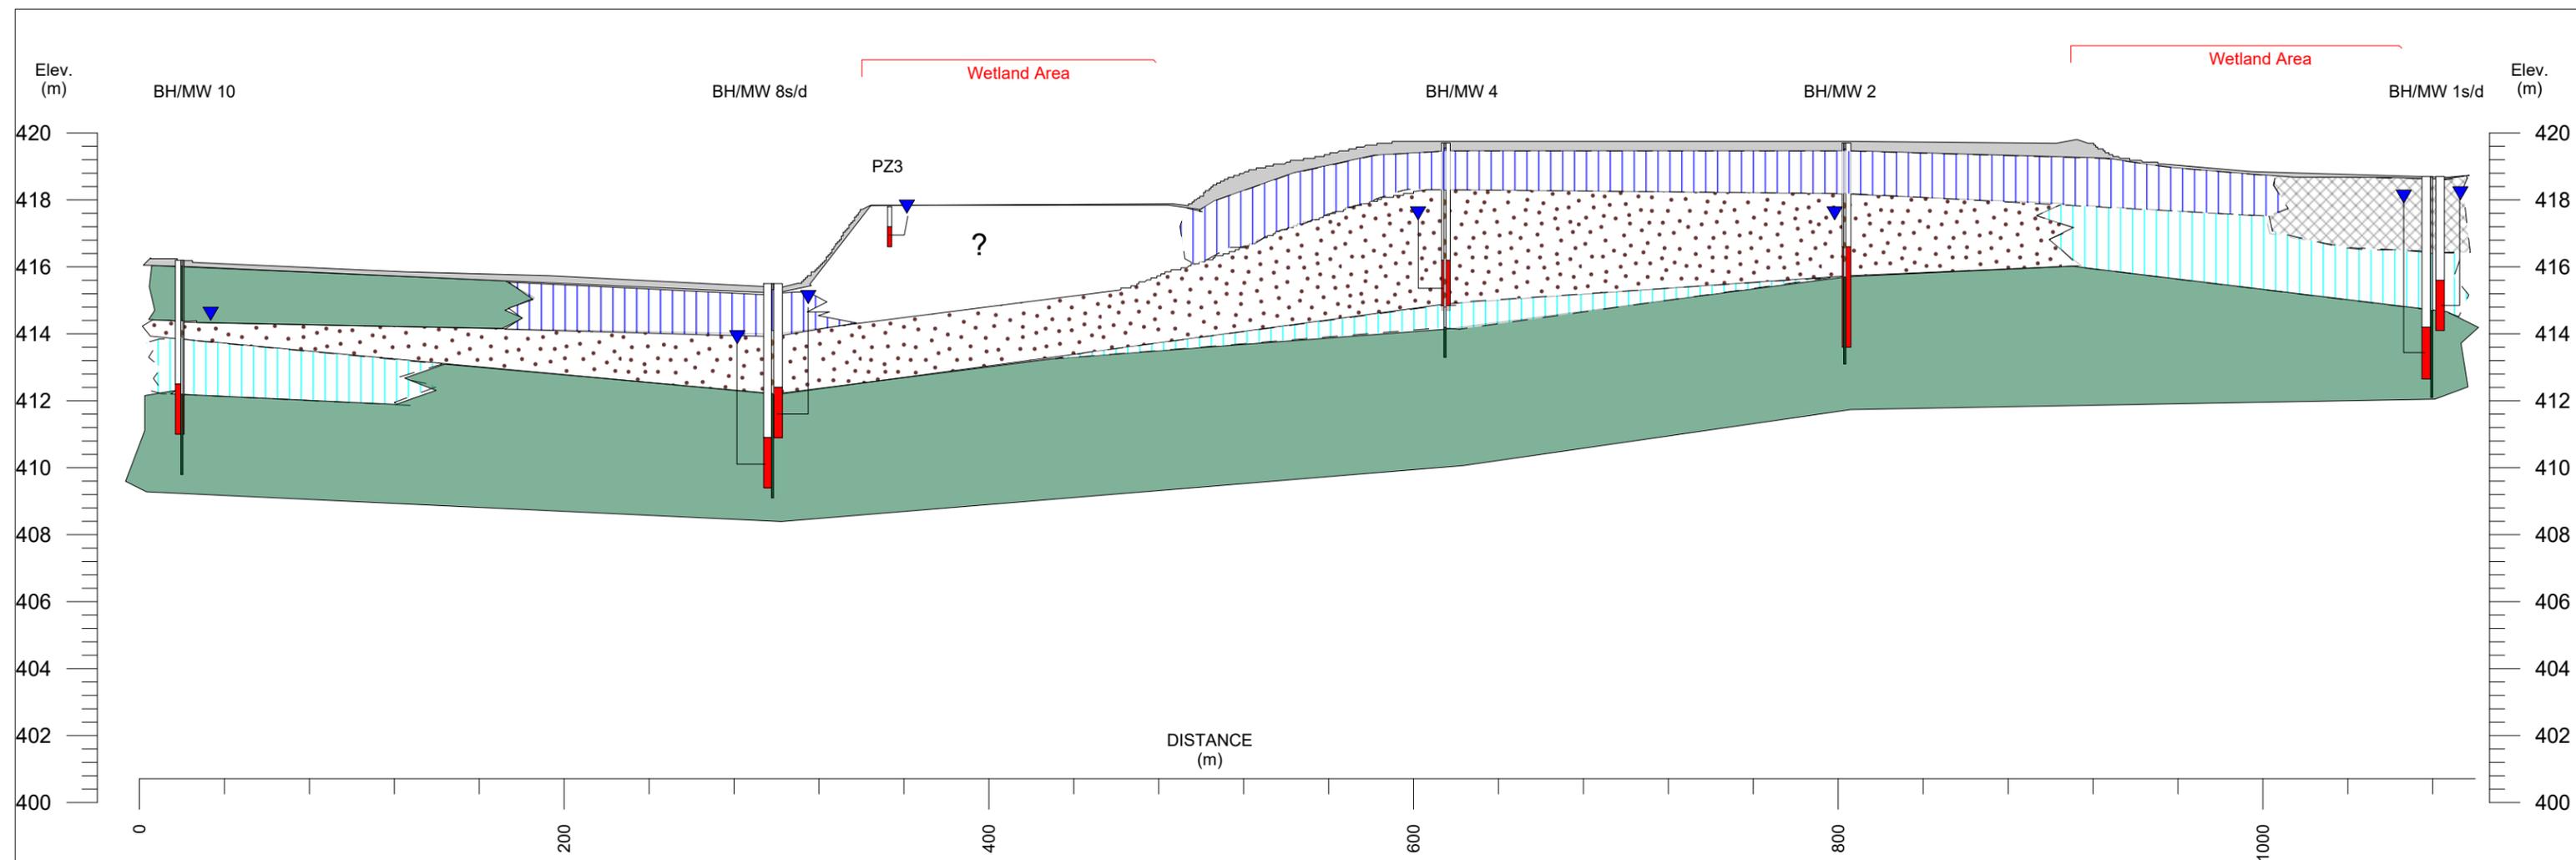
CLIENT SORBAR/TRIBUTE BRUBACHER HOLDINGS INC.	TITLE SITE SPECIFIC CROSS SECTION (B-B')

- Topsoil
- Earth fill
- Silt
- Sandy silt till
- Silty clay
- Sand
- Casing
- Screen
- Water Level (Sep. 2024, taken by Soil Engineers)
