# PRELIMINARY WATER BALANCE ASSESSMENT

6586 Beatty Line North, Township of Centre Wellington,  
County of Wellington, ON

Project #: 24-0837

Date: January 7, 2025

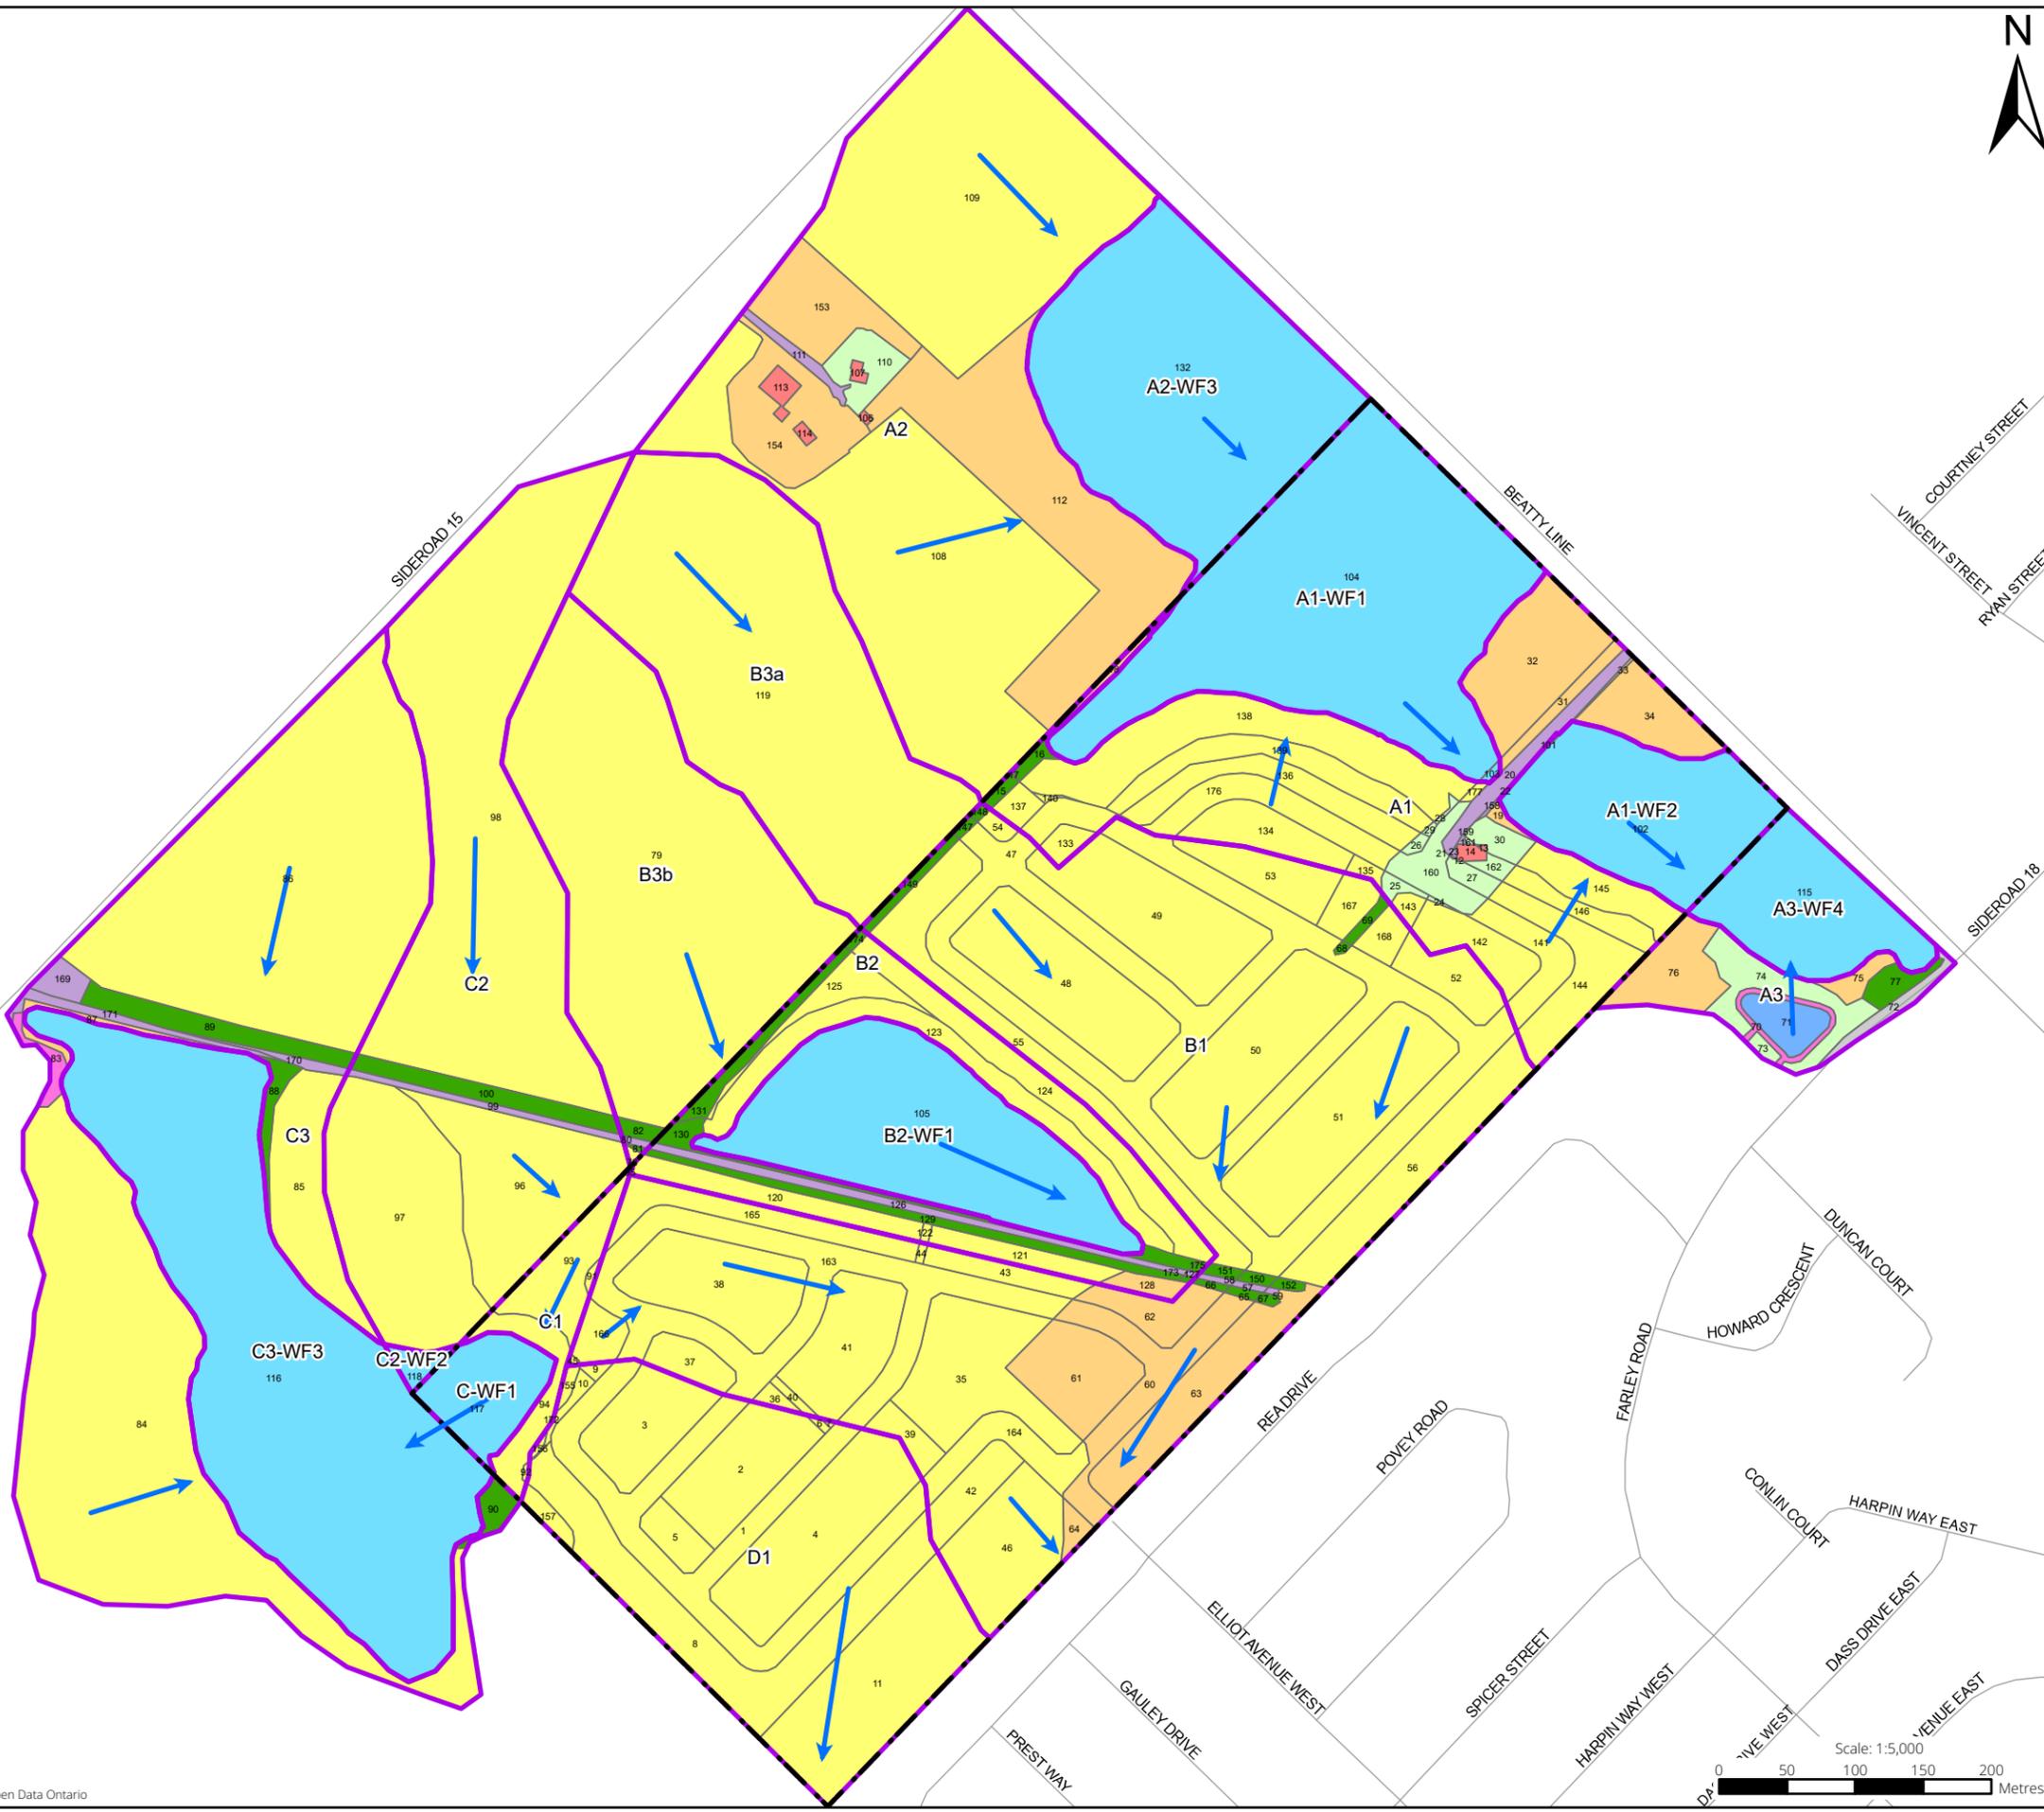
TITLE PRE DEVELOPMENT CATCHMENT AREAS				
PROJECT PRELIMINARY WATER BALANCE ASSESSMENT 6586 BETTY LINE TOWNSHIP OF CENTRE WELLINGTON, ONTARIO				
CLIENT SORBARA/TRIBUTE BRUBACHER HOLDINGS INC.				
PROJECT NO. 24-0837	DATE DECEMBER 2024	PREPARED BY TP	APPROVED BY RB	FIGURE 10

- LEGEND**
- SITE BOUNDARY
  - PRE DEVELOPMENT CATCHMENTS
  - BUILDING
  - CULTIVATED
  - GRAVEL
  - LAWN
  - PAVEMENT / CONCRETE
  - POND
  - ROAD
  - UNCULTIVATED
  - WETLAND
  - WOODLAND
  - PRE DEVELOPMENT FLOW DIRECTION

The on-Site catchment areas have been further subdivided. The drainage sub-catchments are based on similar slopes, soils, and vegetation/land use. The drainage sub-catchments also include consideration of post-development drainage boundaries so that changes to drainage areas can be evaluated for the post-development conditions. The outlets for drainage of the identified Pre-Development catchments are as follows:

Properties associated with area, slope, soil type, and land cover were analyzed and assigned to each Pre-Development sub-catchment. The values assigned to each Pre-Development sub-catchment were used to estimate an Infiltration Factor. The Infiltration Factors were reviewed to confirm that they are appropriate and adjusted if necessary. Existing building areas were assumed to be impervious and to generate runoff equivalent to the precipitation volume minus a 10% evaporative loss. Gravel areas were assumed to have a surplus equivalent to that of urban lawn areas.

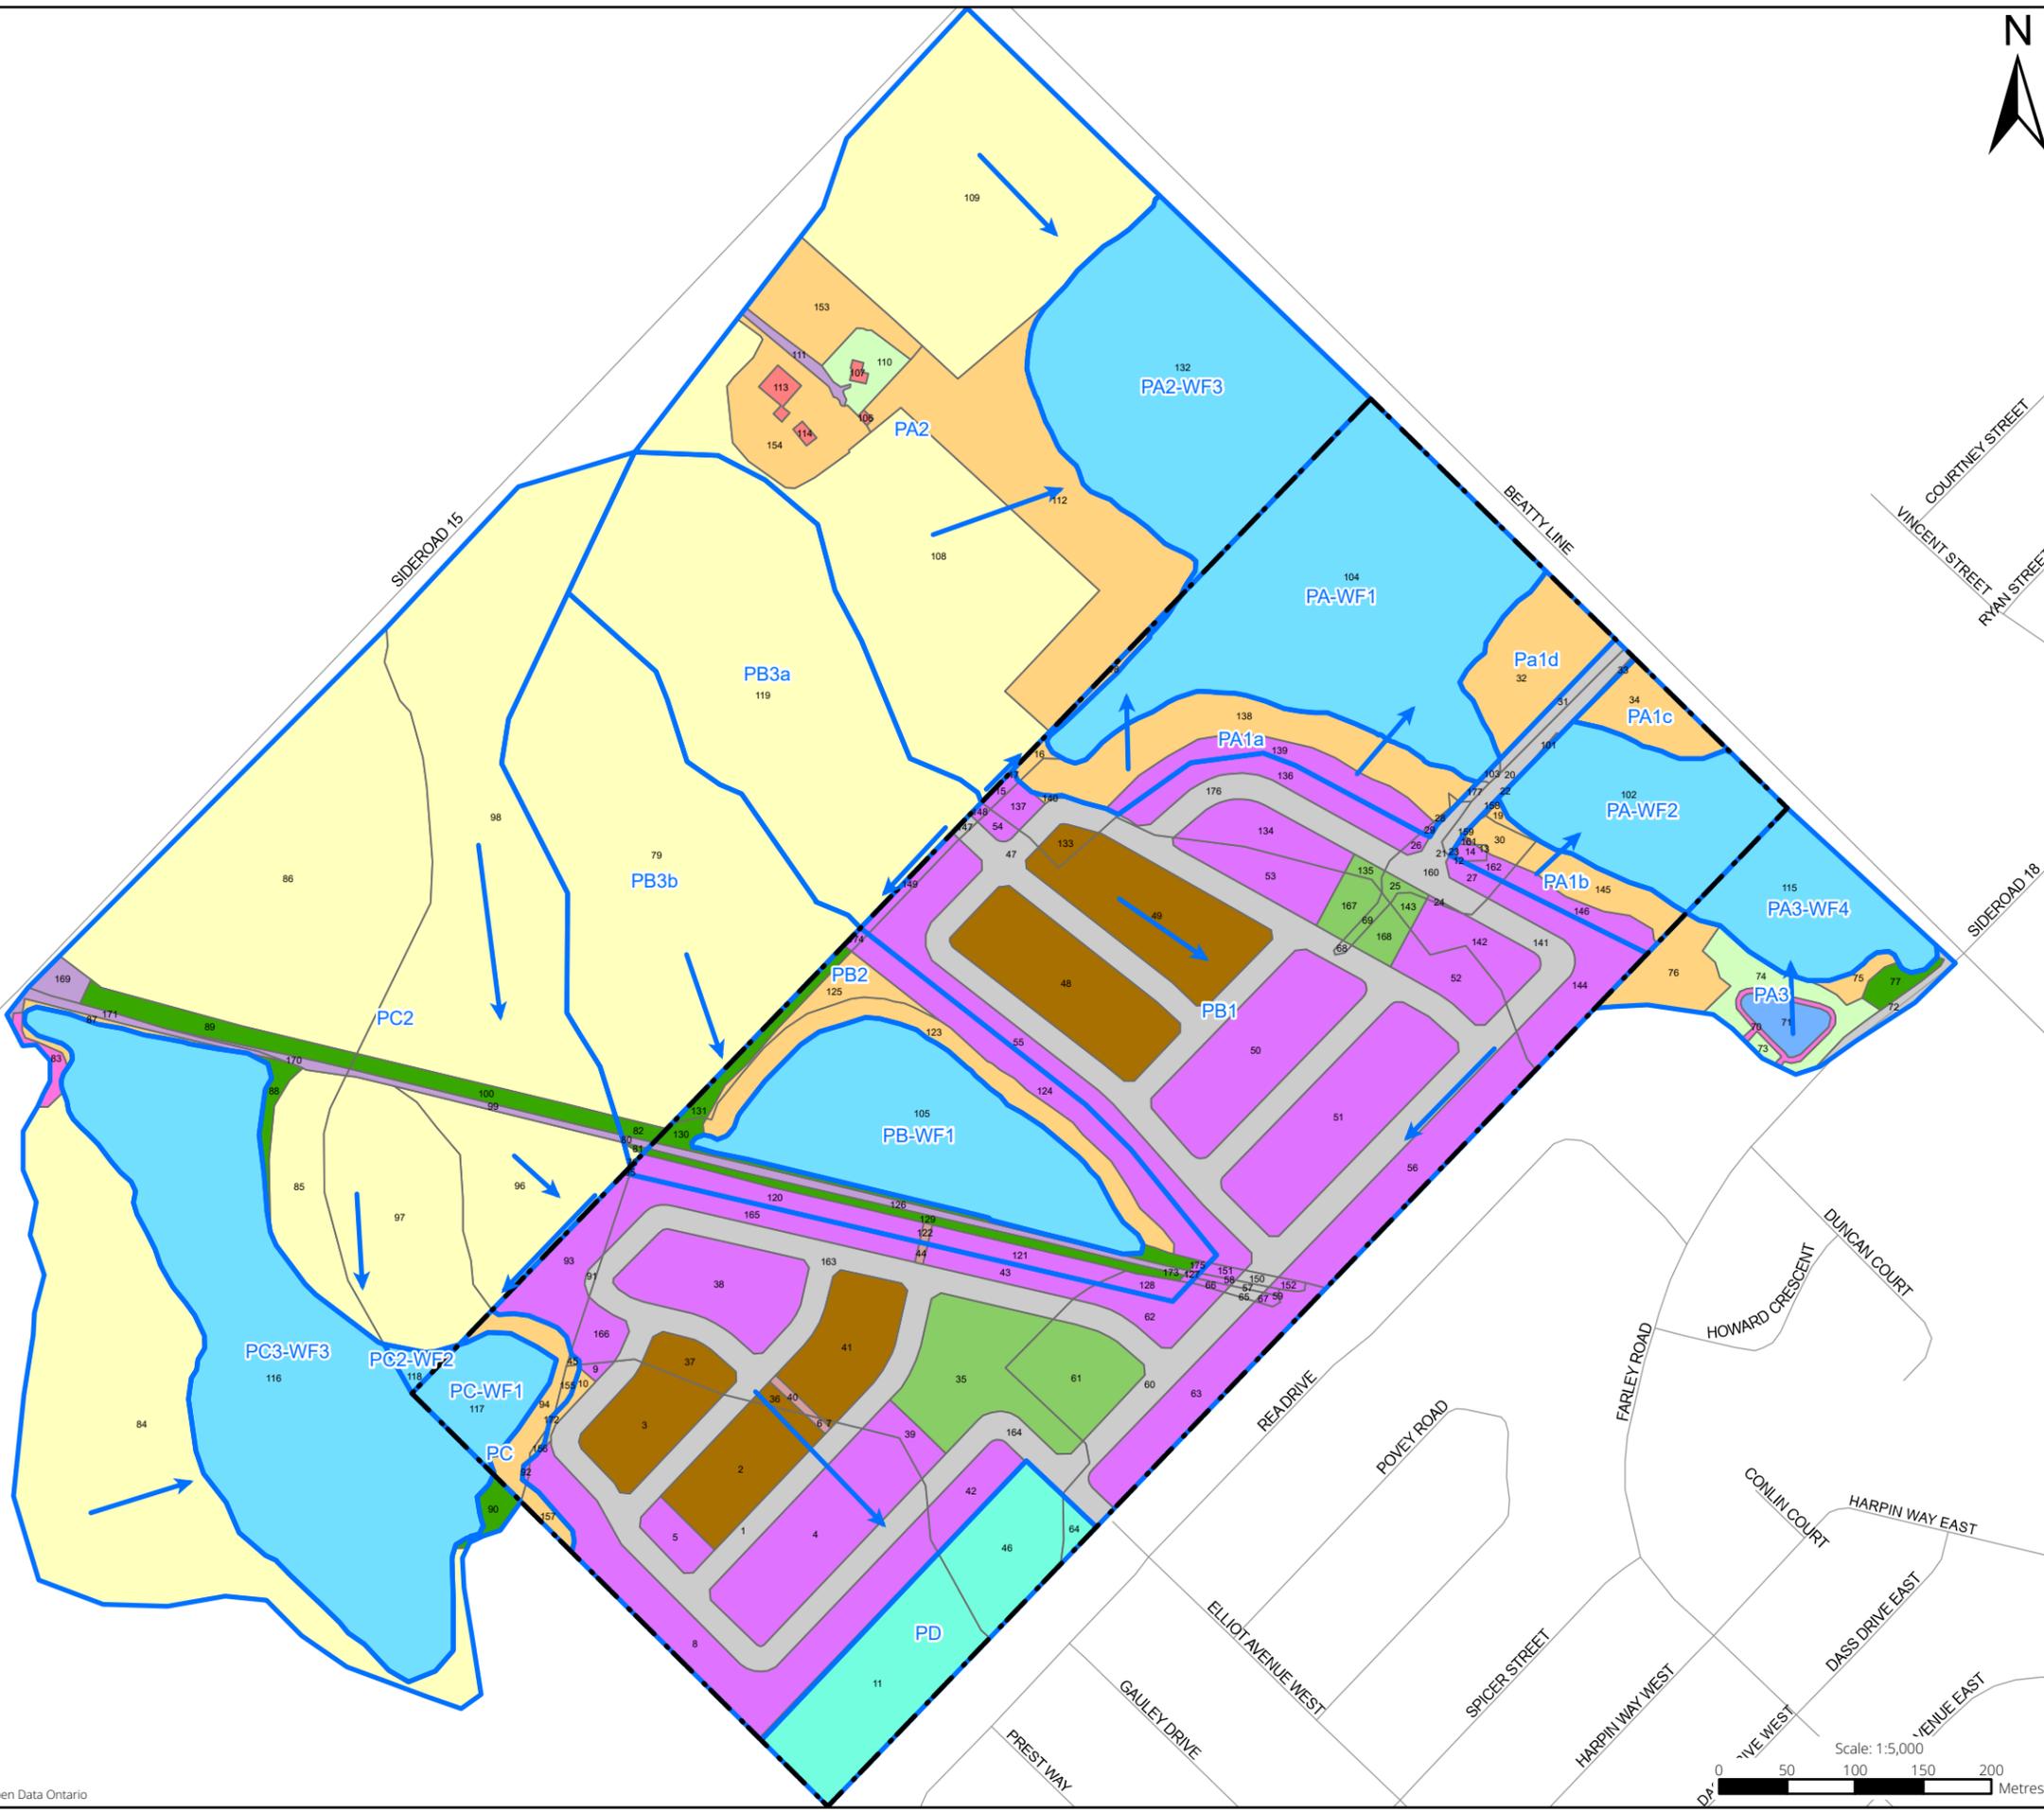
TITLE POST DEVELOPMENT CATCHMENT AREAS				
PROJECT PRELIMINARY WATER BALANCE ASSESSMENT 6586 BEATTY LINE TOWNSHIP OF CENTRE WELLINGTON, ONTARIO				
CLIENT SORBARA/TRIBUTE BRUBACHER HOLDINGS INC.				
PROJECT NO. 24-0837	DATE DECEMBER 2024	PREPARED BY TP	APPROVED BY RB	FIGURE 11

LEGEND	
	SITE BOUNDARY
	POST DEVELOPMENT CATCHMENTS
	BUILDING
	CULTIVATED
	DETACHED
	PARK
	GRAVEL
	LAWN
	PAVEMENT / CONCRETE
	POND
	ROAD
	SWMP
	TOWNHOUSE
	UNCULTIVATED
	WALKWAY
	WETLAND
	WOODLAND
	POST DEVELOPMENT FLOW DIRECTION

**Figure 11** illustrates the delineation of drainage catchments and sub-catchments for the Site under post-development conditions. The Site has been subdivided into six (6) on-site catchments. Sub-catchment delineations in Pre- Development conditions were maintained for the Post-Development analysis. The post-development catchments were prepared based on a preliminary grading plan and drainage area plan provided by SCS.

Runoff from within the developed areas of the Site drains offsite to the south through the existing storm sewer, or to the existing wetland features for infiltration. EnVision has assumed that the runoff from the upgradient properties (to the north) will be conveyed through the wetland areas. The outlets for each Catchment are summarized below:

- Post-Development On-Site Catchment PA1 and PA2: Drains off-site to the wetland complex or to the tributary east of the property.
- Post-Development On-Site Catchment PB: Infiltration through the central wetland feature.
- Post-Development On-Site Catchment PC: Drains to the south storm sewer via overland flow through the stormwater management feature (PD).
- Post-Development On-Site Catchment PD: Drains to the south storm sewer.
- Post-Development On-Site Catchment PE: Drains to the western wetland feature.
